ARLINGTON FINANCE COMMITTEE
MINUTES OF MEETING
03/8/2023 7:30 PM
Via Remote Participation - Zoom

ARLINGTON TOWN HALL EXTERIOR CONDITIONS ASSESSMENT & RECOMMENDATIONS

December 2022

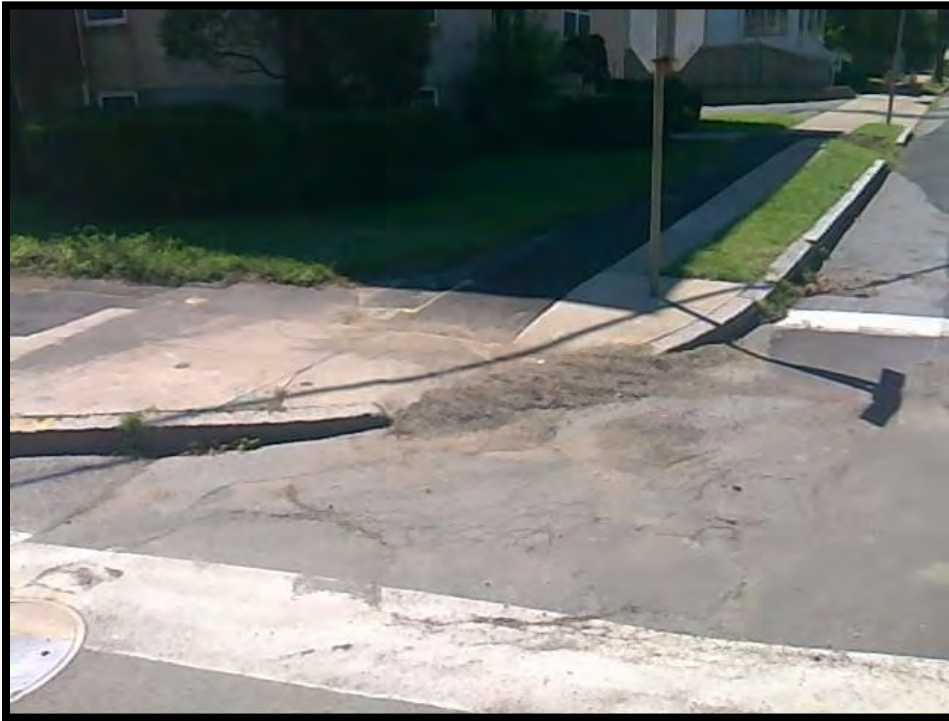
Fair Condition Ramp - Massachusetts Avenue and Robbins Road

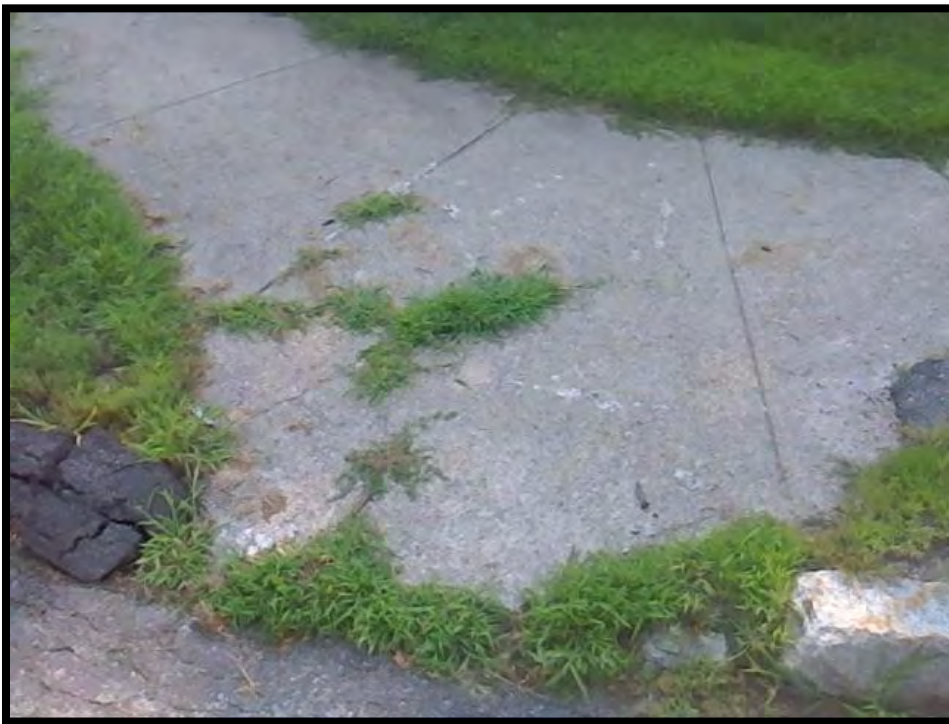
Poor Condition Ramp – Tanager Street and Aberdeen Road

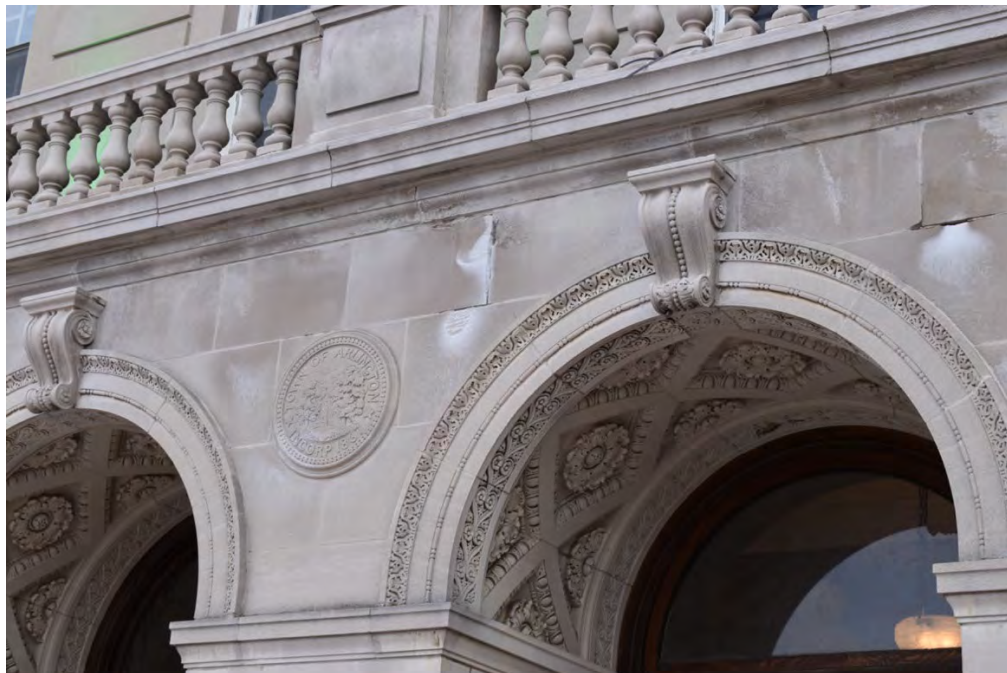
Photo 2: Water flowing from the balcony roof through the open joints at the top of the cornice is entering the wall and causing the deterioration of the ashlar units between the above the arches.

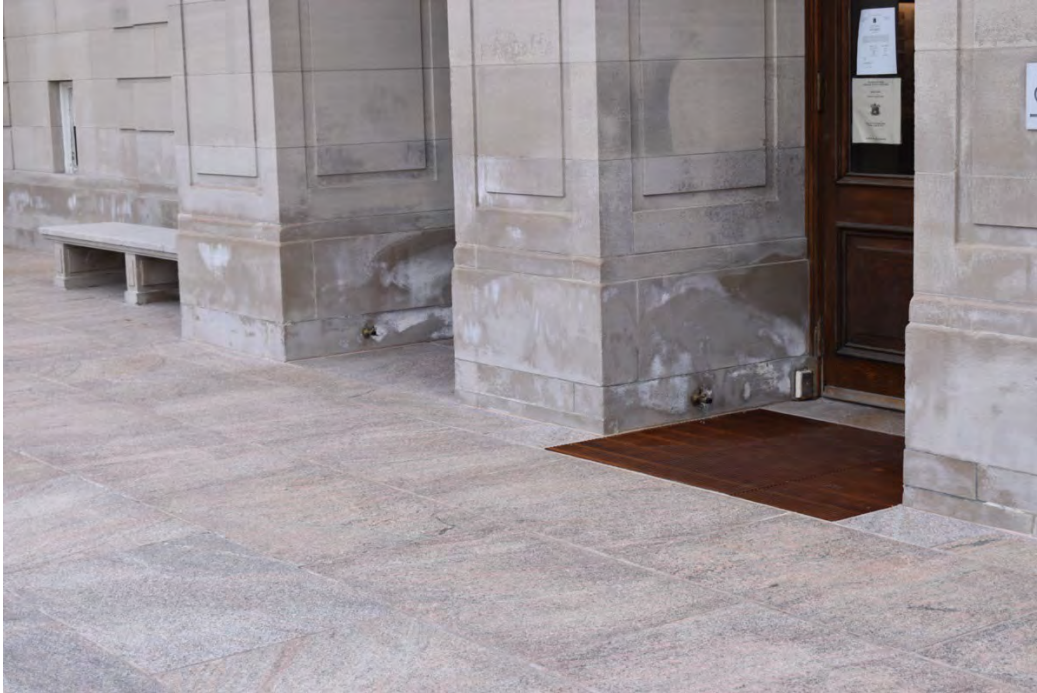
Photo 3: Moisture containing dissolved deicing salts is being pulled into the stone from the granite plaza at the base of the north elevation.

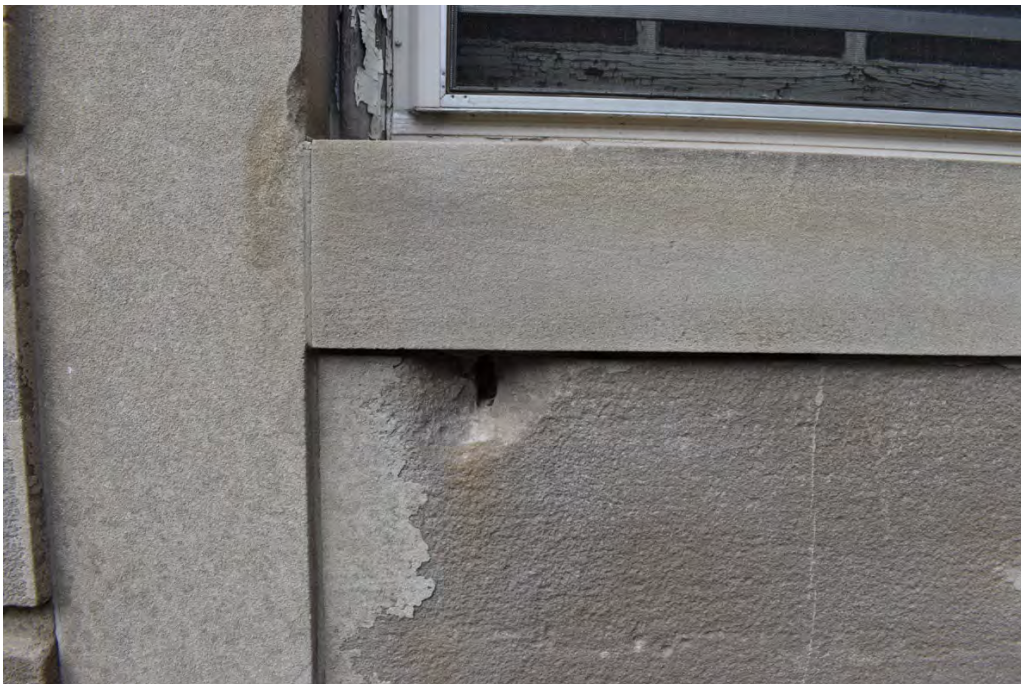
Photo 4: Moisture wicking up from the ground on the west elevation has discolored the stone and caused the anchor securing the stone to the backup masonry to corrode. The expansive force of the corroding steel has spalled the stone below the sill.

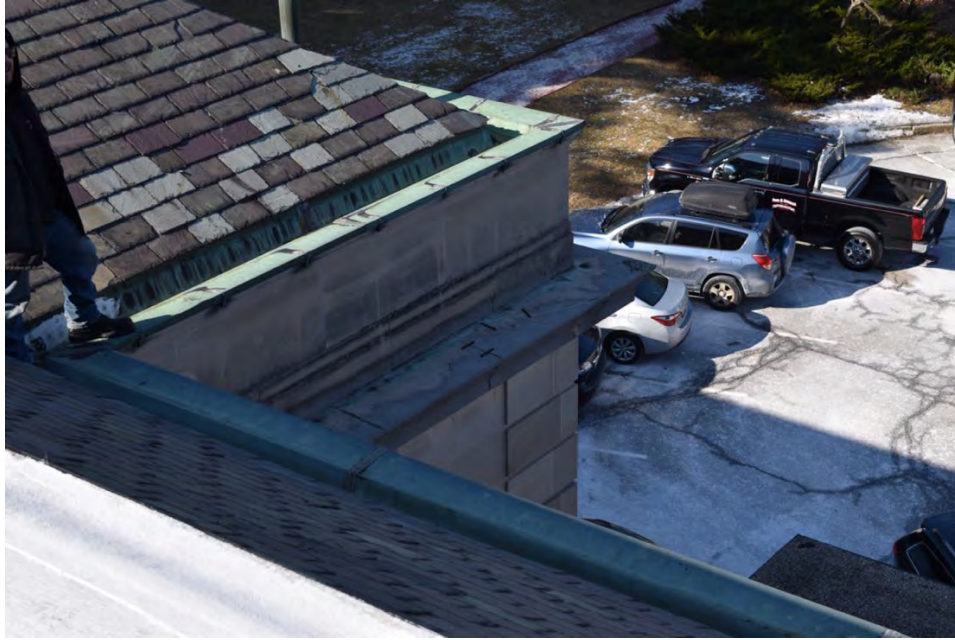
Photo 5: The cornice unit at the corner of the wing on the west elevation cracked at some point in the past. The crack was repaired with four or five steel staples that bride the crack and the joint. The steel staples are rusting and possibly re-cracking the stone. This unit requires additional investigation.

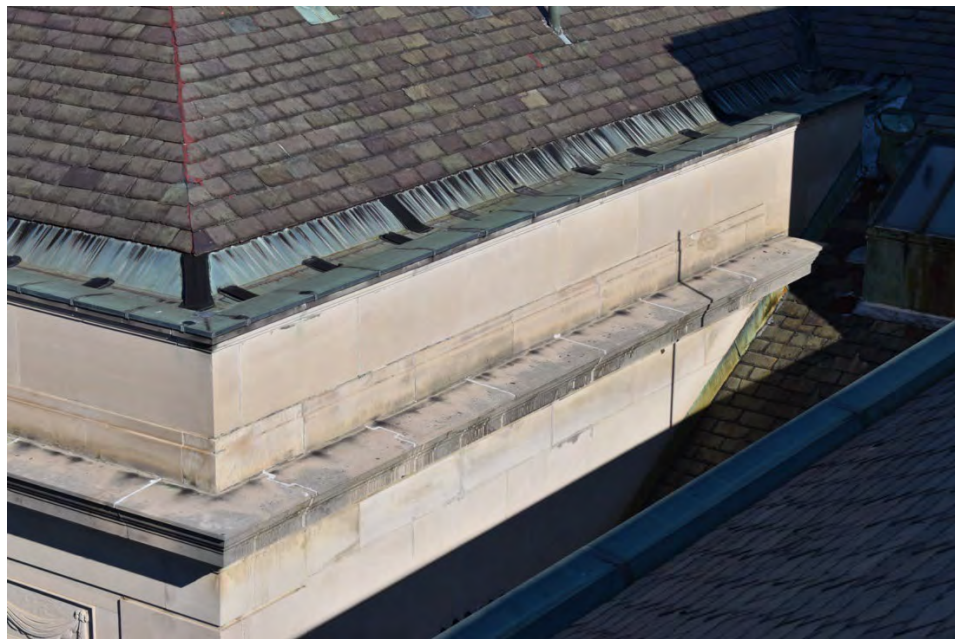
Photo 6: The upward facing joints on the parapet are protected by the copper gutter but the upward facing joints on the cornice are unprotected. The face and top of the cornice are stained from biological films colonizing the weathered stone.

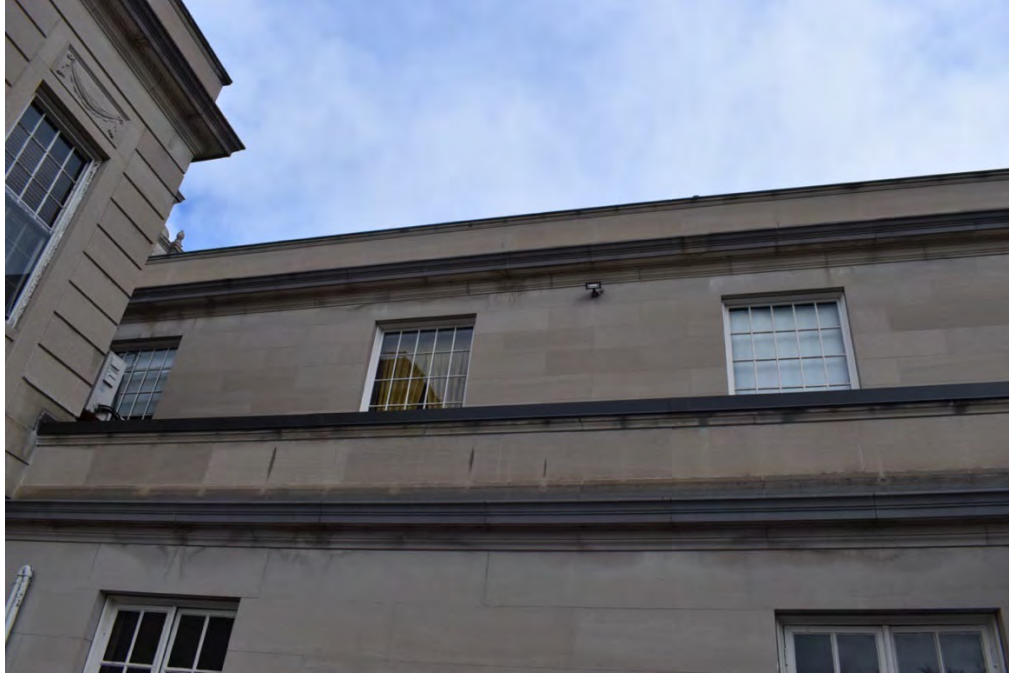
Photo 7: Water flowing through the open joints at the top of the cornice is responsible for the staining and deterioration of the ashlar units below the cornice.

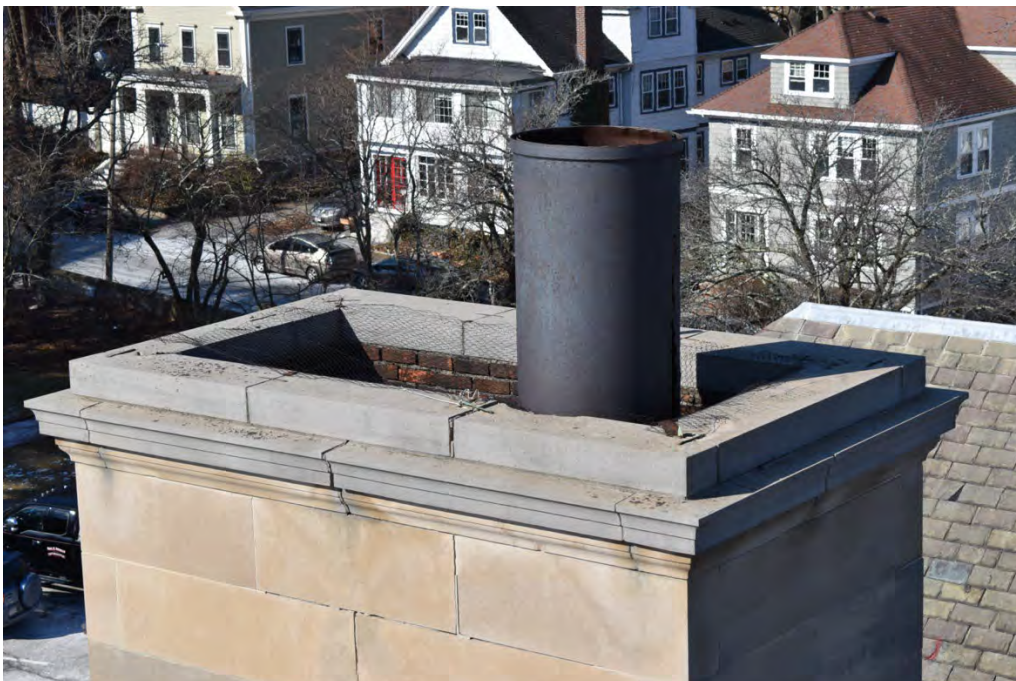
Photo 8: The mortar in the chimney joints is completely failed. The coping units have shifted slightly as a result of water freezing in the open joints. The brick joints inside the chimney are in need of repointing.

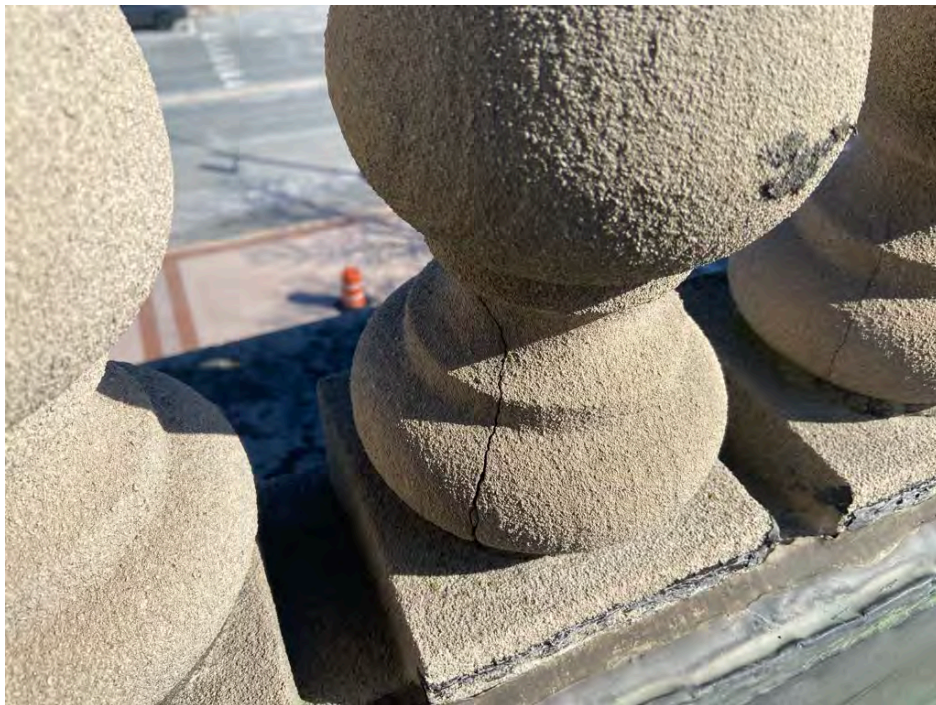
Photo 10: Individual balusters in two bays on the north elevation are cracked at the top and bottom. The cause of the cracking is most likely the corrosion of steel pins used to secure the balusters in place.

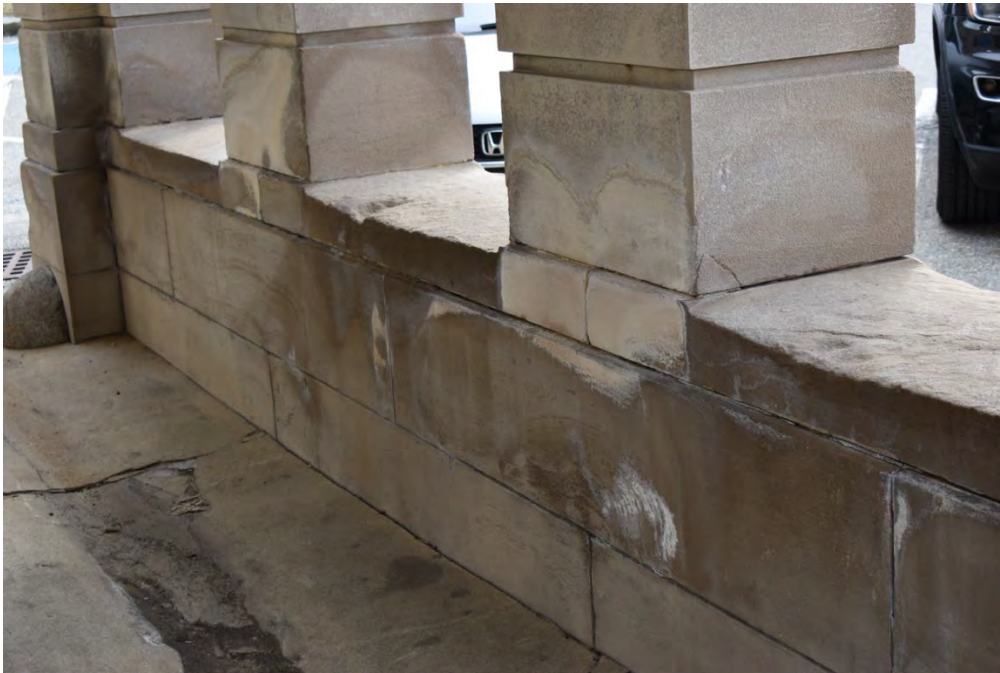
Photo 11: The limestone units on the interior of the porte cochere are stained and damaged from water infiltration at the top and bottom of the low wall. Some of the units were repaired in the past. The earlier repairs have reached the end of their service life.

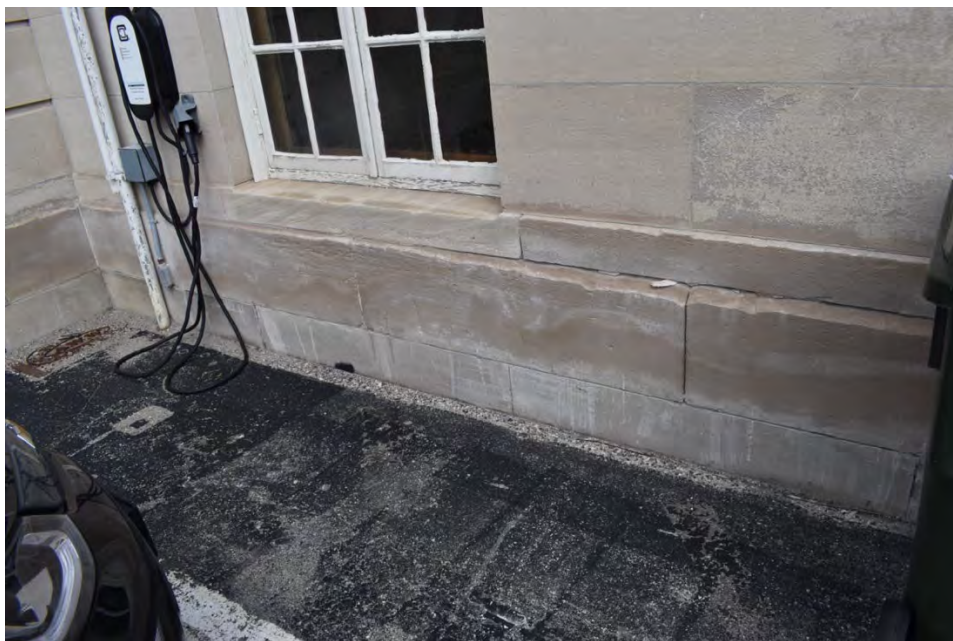
Photo 12: The stonework at the base of the west elevation is stained from moisture wicking into the stone from the parking lot asphalt. The edges of the stone units at the ledges appear to be damaged from frost.

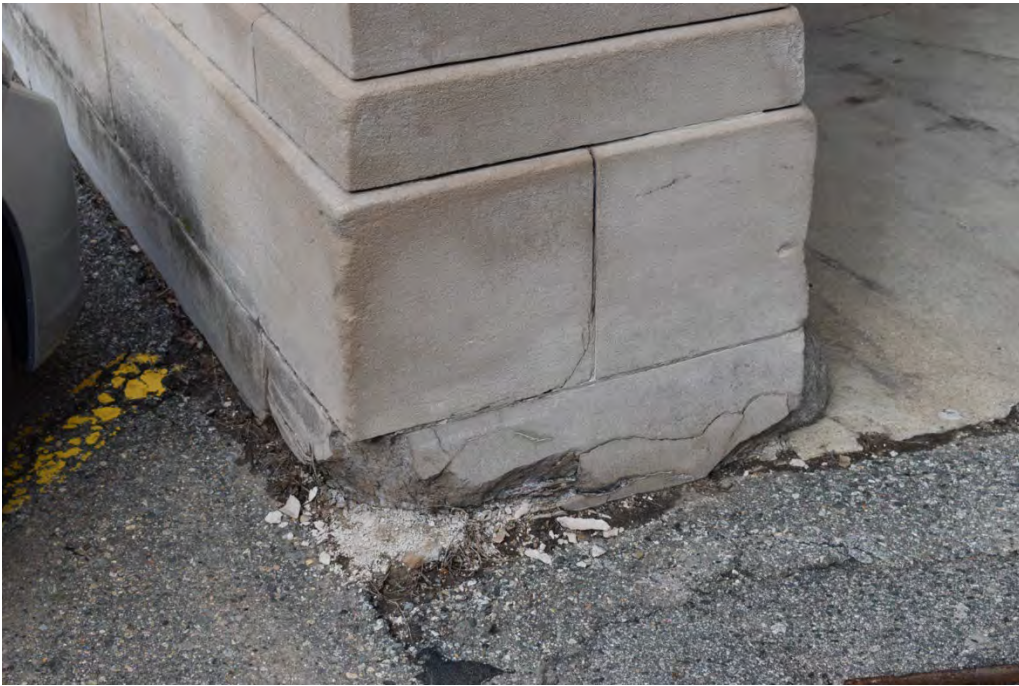
Photo 13: The corner unit at the base of the wall is fractured as a result of frost damage.

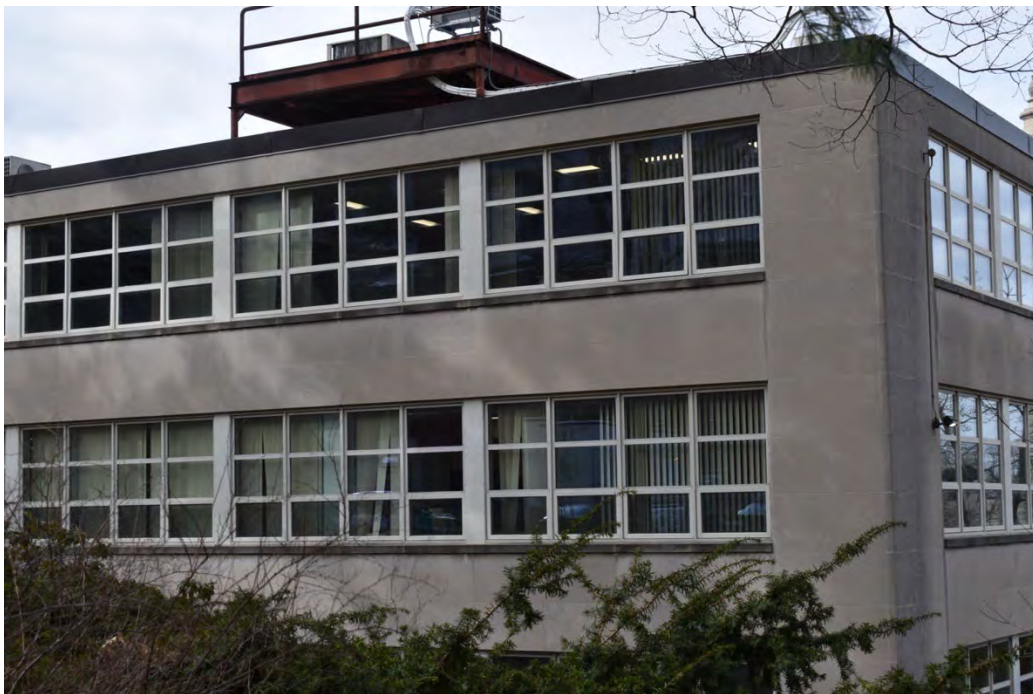
Photo 14: South elevation of the addition. The limestone panels are in good condition but the mortar joints are severely eroded.

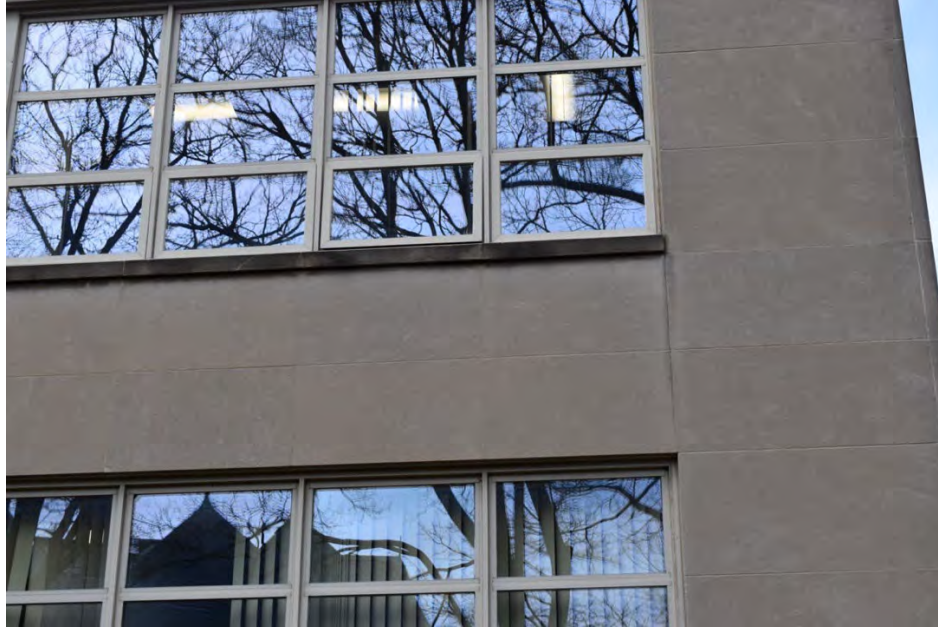
Photo 15: Water flowing off the edge of the sill is responsible for the deterioration of the vertical mortar joint below the corner of the sill.

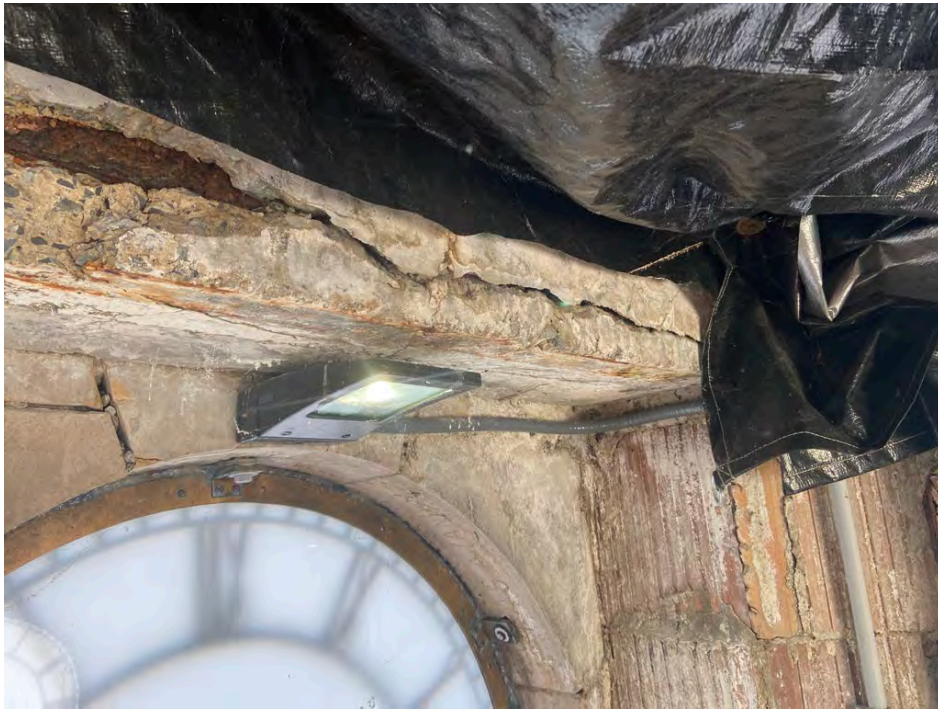
Photo 17: The concrete frame inside the clocktower is cracked from the expansion of the corroded steel reinforcement inside the concrete.

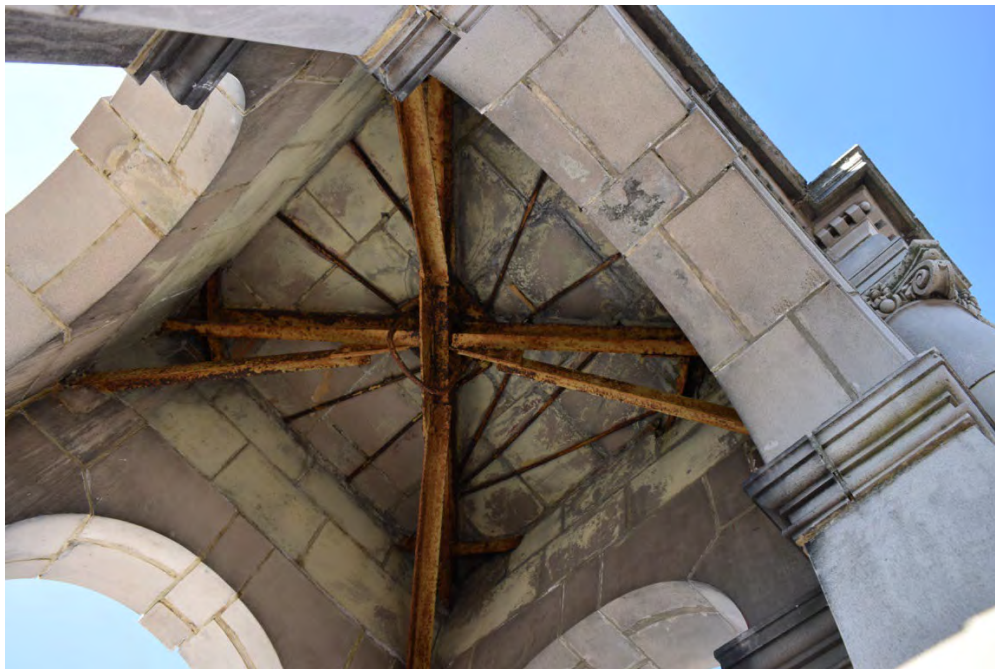
Photo 18: The steel frame that supports the belfry roof is rusting. Corrosion at the buried ends of the steel members is cracking and displacing the terra cotta.

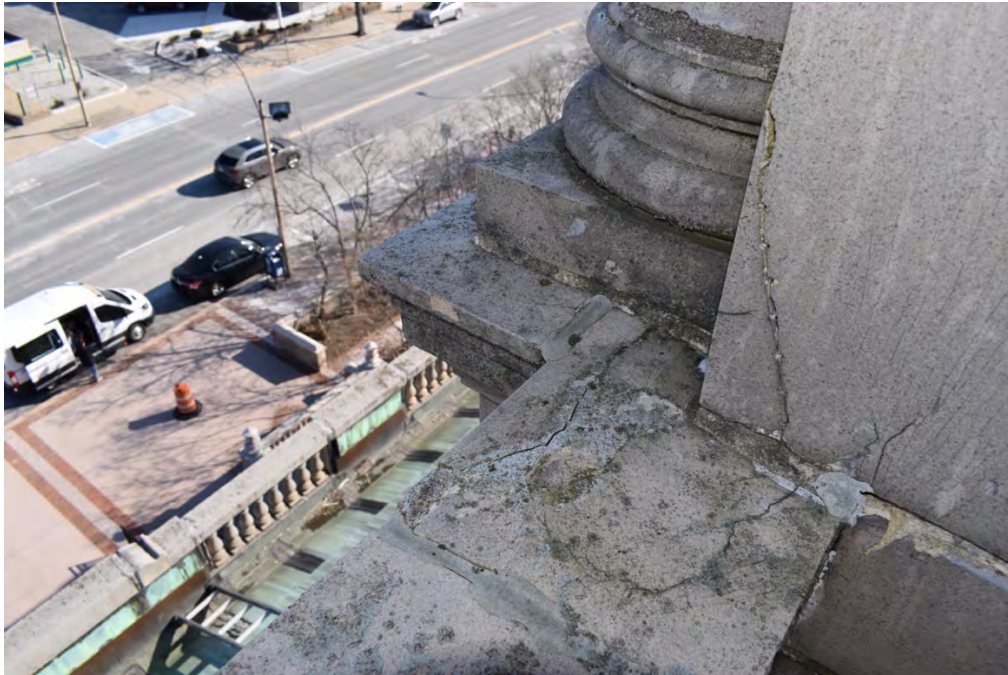
Photo 19: The top surface of the terra cotta sill units and the adjacent jamb are cracked in several locations.

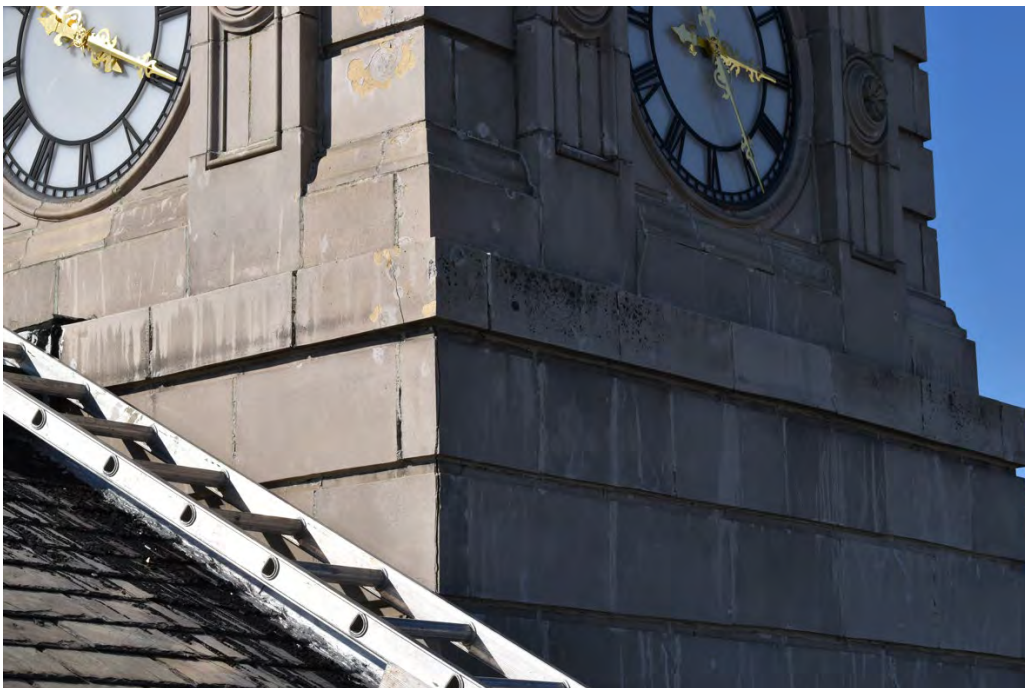
Photo 20: The terra cotta units at the northeast corner are cracked on both faces of the corner.

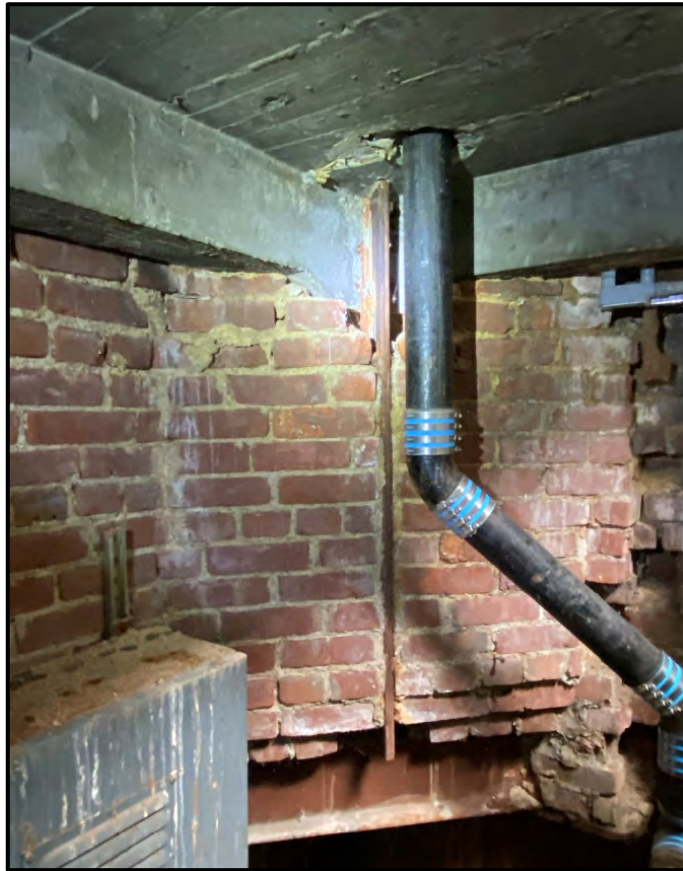
The concrete encased steel beams spanning to the columns and supporting the level 1 platform above appear to be in good condition with no signs of rust staining, cracking, or spalling of the concrete encasement.

Figure 3 The concrete encased members supporting the level 1 concrete platform appear to be in good condition.

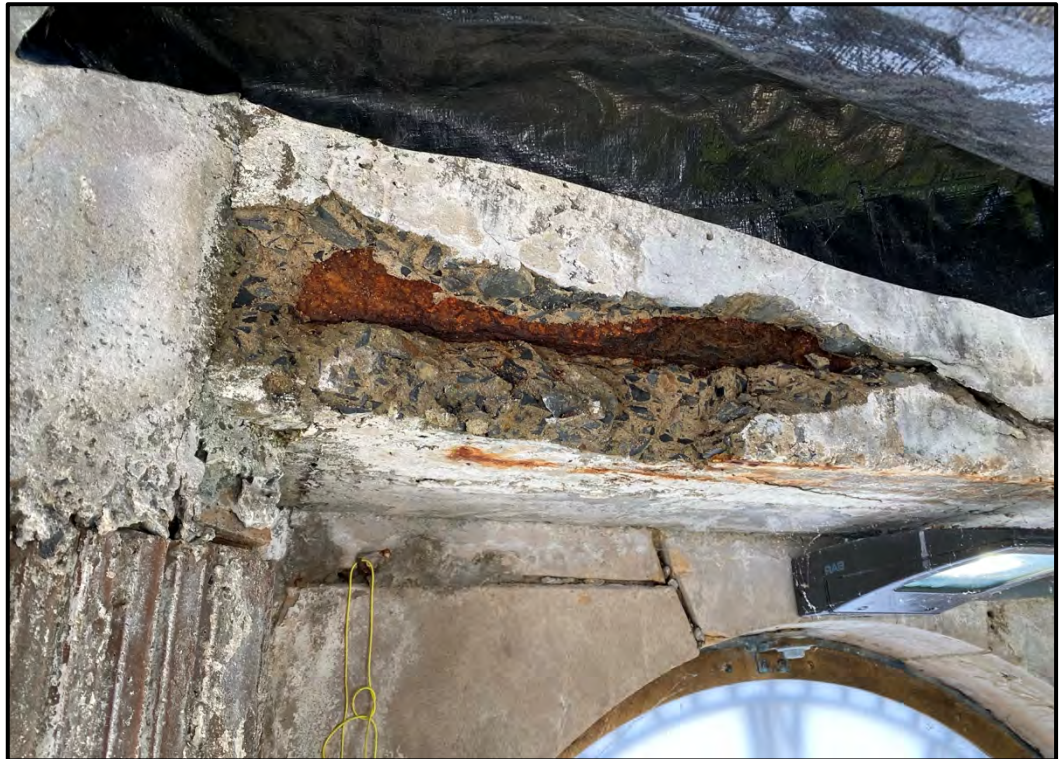
Figure 6 A piece of concrete encasement was removed from the beam to expose the significant corrosion of the member.

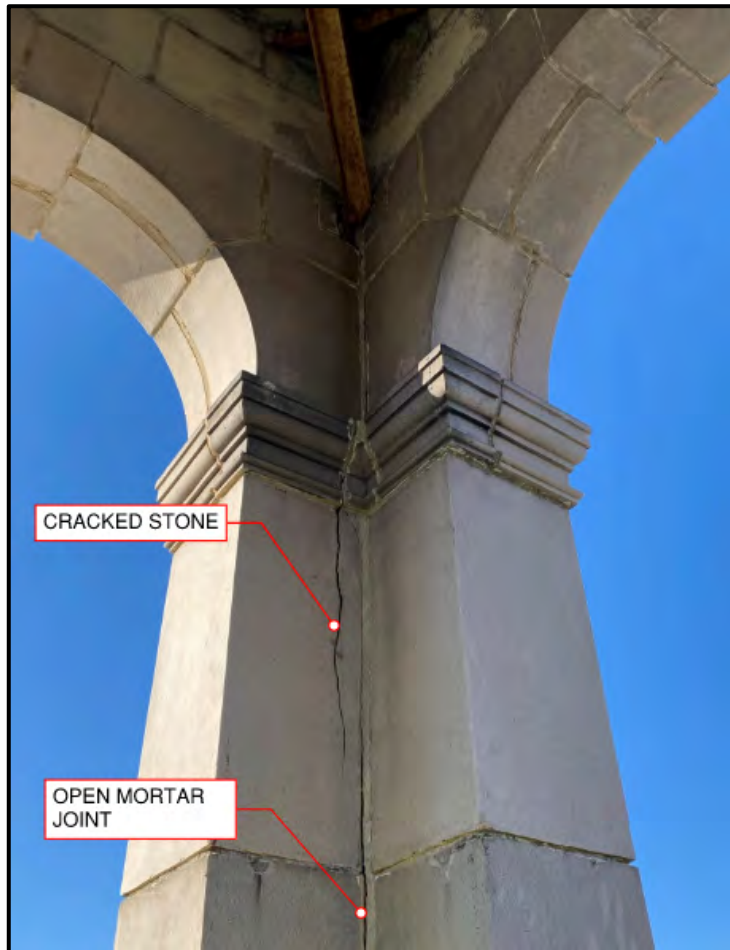
The stone cladding around the double angle columns is cracking and the vertical joints between the stones are opening up (see figure 8). Based on earlier stated observations at the interior, this is likely due to corrosion of the columns leading to rust jacking of the stones.

Figure 8 The stone cladding around the column is cracking and the vertical joints between the stones are opening.

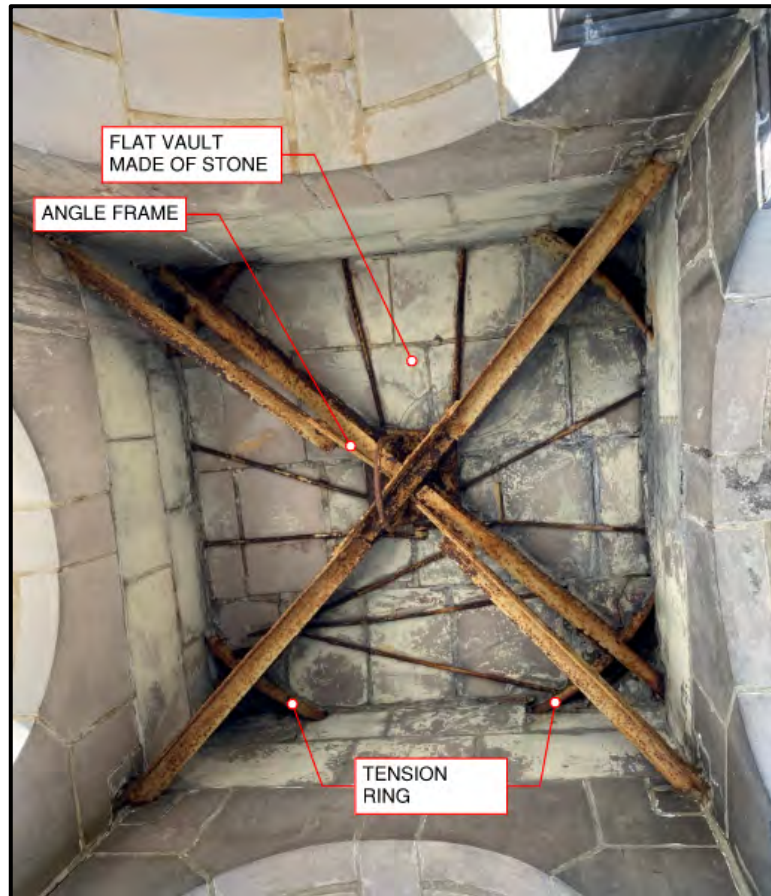
Figure 9 The angles and tension ring supporting the stone flat vault are showing signs of surface rusting.

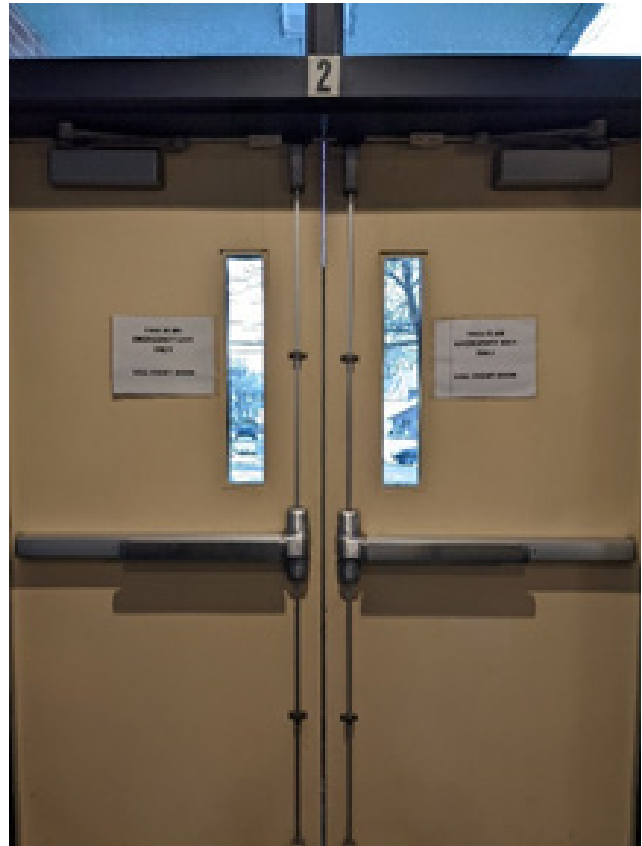
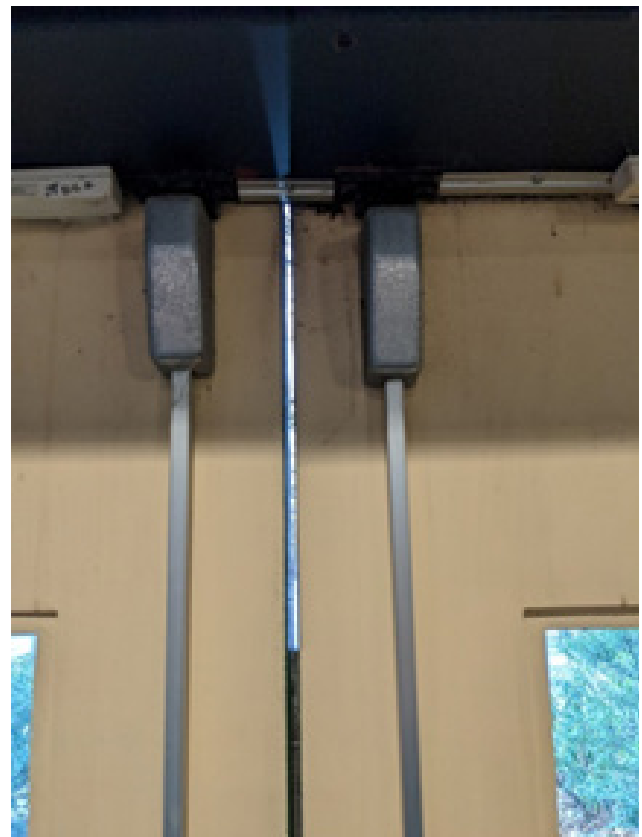
Figure 1 and 2 *Example Infiltration at Peirce Elementary School*
